Manhole Inspection Summary

Manhole # S21CC1016MH

Insp Date: **2/22/07 10:56 AM**

Location Address: **CLIPPER RD**

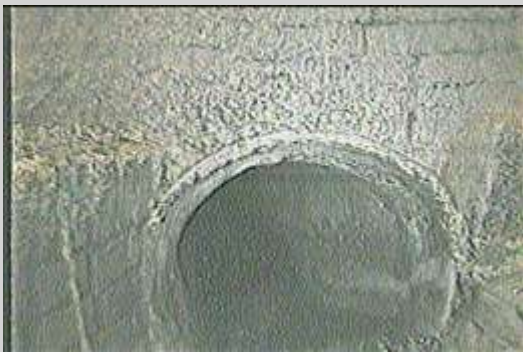
18 in. Circular Gravity Sewer Pipe Out @ 12 O'Clock

Pipe Material: **Unknown** ☒ Pipe Lined

Invert Depth: **13.12** (ft.) Flow Characteristics: **Fast**

Deposits: ☒ None ☐ Mud ☐ Sludge ☐ Debris ☐ Grease

Infiltration: **None** Pipe Seal Cond: **Unknown**

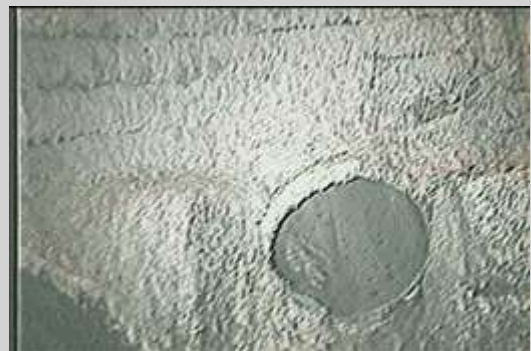
Drop In @ 1 O'Clock

Drop: **Outside** Rod and Bar

Angled: **Yes** Reading: **11.29** (ft.)

Drop Condition: **Open**
